Phase I and II Environmental Site Assessment

Powder House School
1060 Broadway
Somerville, Massachusetts

March 6, 2014

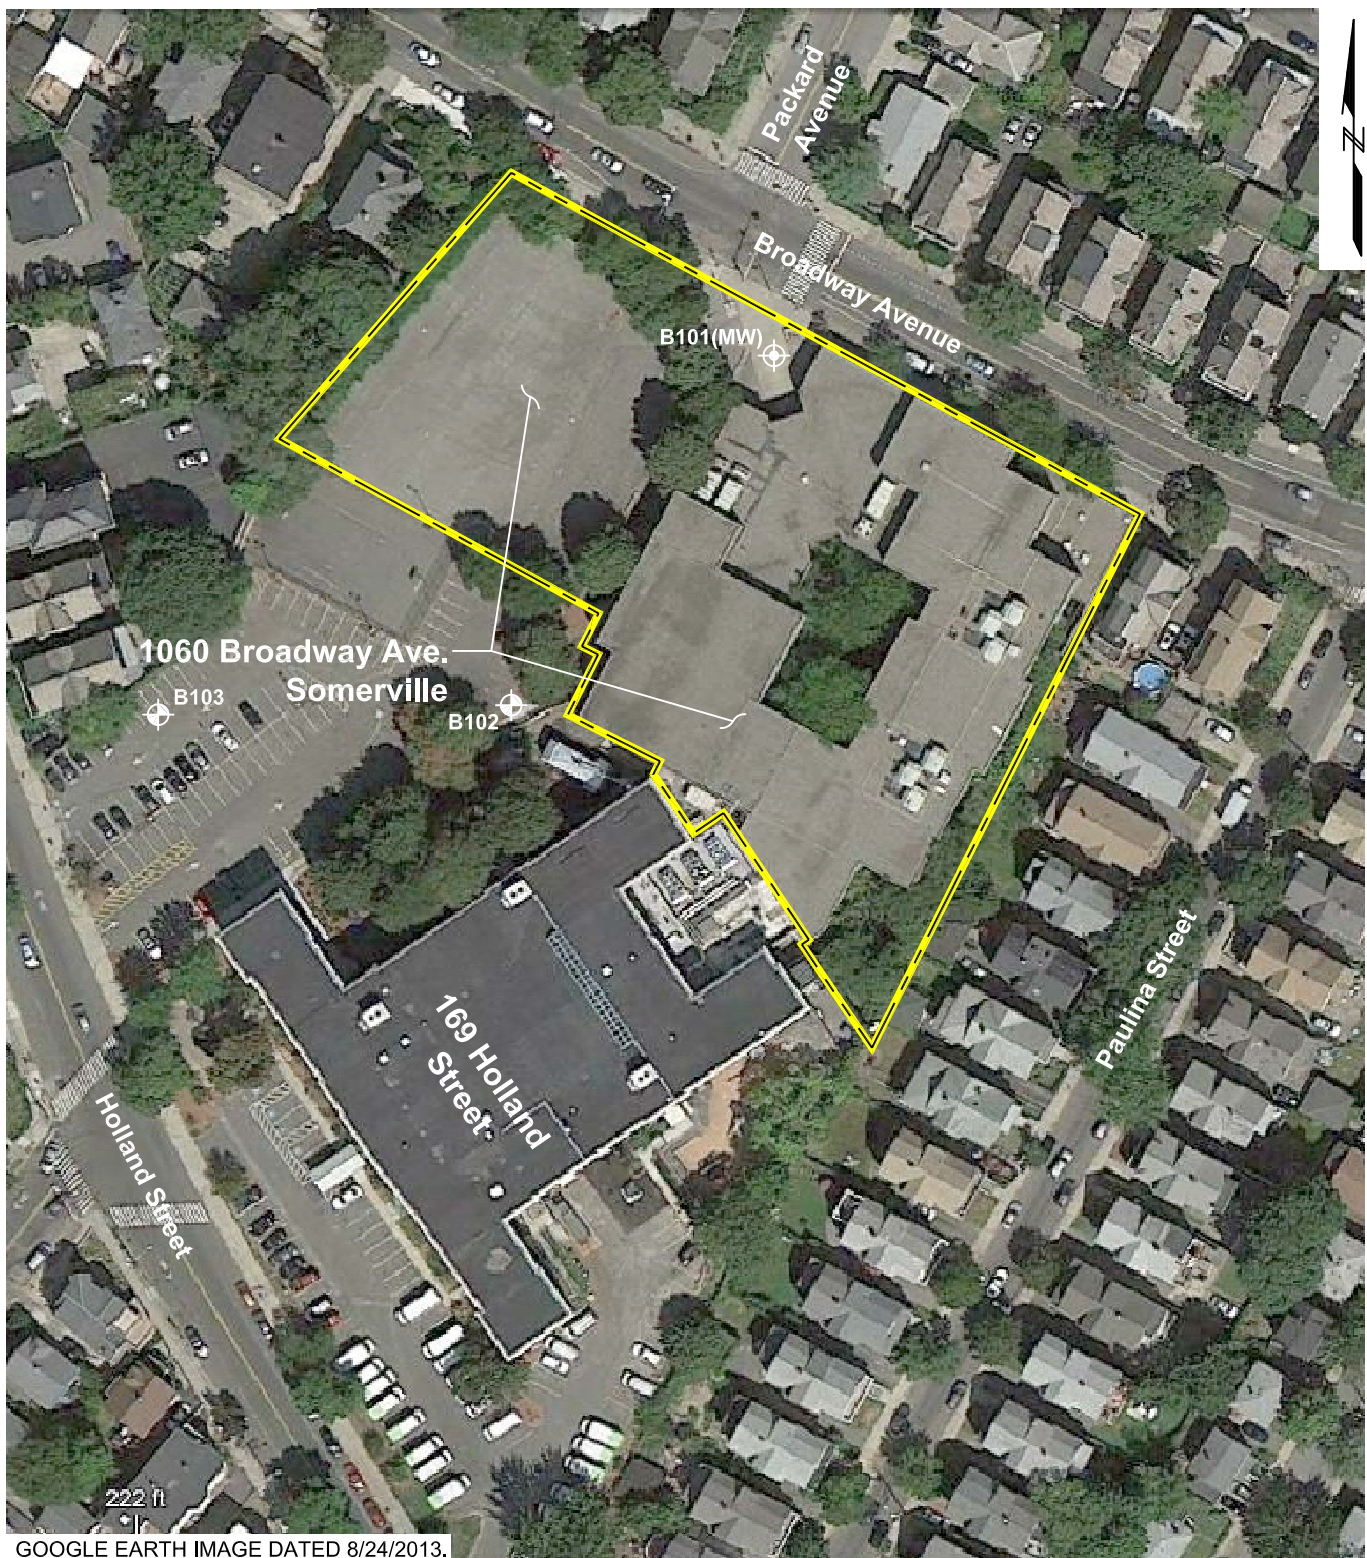
On February 14, 2014, we observed Northern Drill Services (Northern) of Northborough, Massachusetts advance 3 soil borings (B101 through B103) to depths ranging from 7.25 to 16 feet using hollow-stem auger, drive and wash, and rock coring drilling methods. The soil boring locations are shown on Fig. 2 and boring and monitoring well installation logs are in Appendix I.
